**Bridge Hydraulics Report**

# Lem Turner Road (SR 115) Over Trout River Bridge Replacement Bridge No. 720033

Duval County, Florida

June 2023

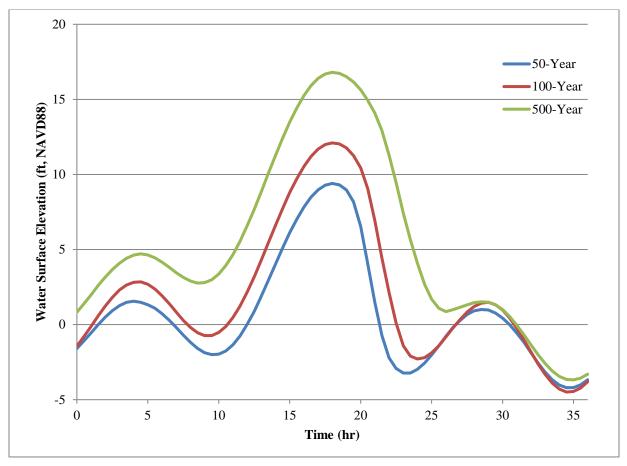
Figure 2-4 FDOT Storm Surge Hydrographs at Manhattan Beach

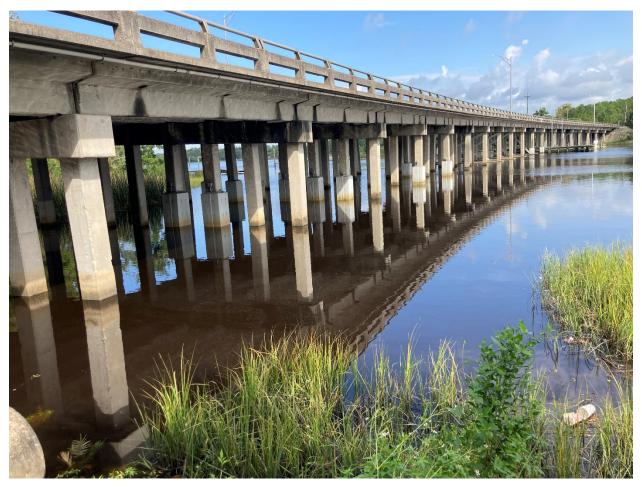
INTERA engineers visited the project site on August 24, 2021. FDOT road maintenance crews were working at the site during the visit. The existing structure is supported by inline pile bents with eight piles at each bent. Some of the piles were repaired with pile jackets. Beneath the bridge the waterway is generally clear except low density grass towards the bridge ends. The abutments are protected by sand cement bags under the bridge and grout on the sides. There is vegetation growth on sand cement and various cracks. There have been numerous repairs of the sand cement with grout. There was fresh repair on the south side. The sand cement bags at the toe of the south side abutment are scattered below the water level. Figure 2-5 shows the east face of the existing bridge. Additional photos are contained in Appendix B.

Figure 2-6 Downstream Face of Existing Bridge

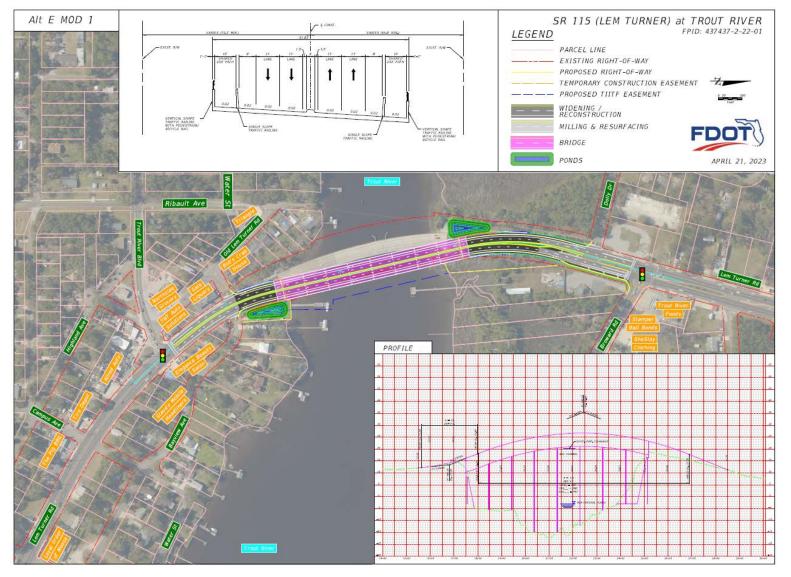
The proposed Lem Turner Bridge Replacement Alt E Mod 1 will move the bridge alignment slightly east, switching from a curved to straight alignment. It will consist of eight 96' spans with a total bridge length of 768' (Figure 2-6). The seven interior inline pile bents consist of eight 24" square concrete piles spaced at 12'. The inline bents are not skewed from the roadway centerline.

Figure 2-7 Proposed Bridge (Alt E-Mod1) Plan and Elevation (Source: Parsons)

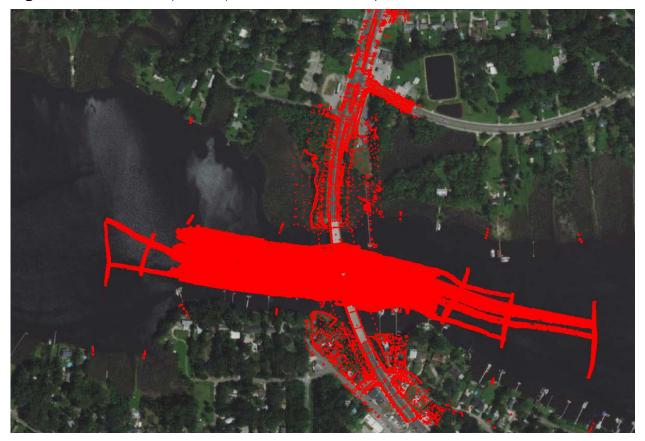
Figure 2-8 Bathymetric Survey Extents

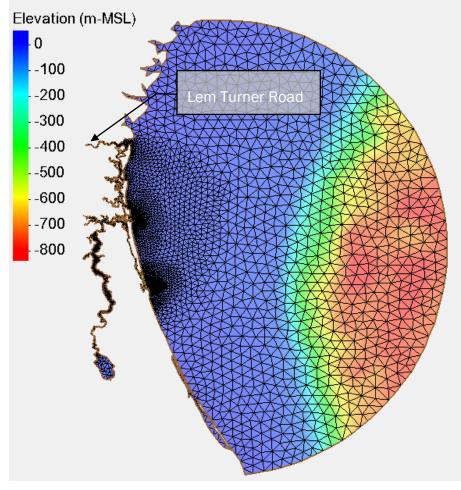
INTERA developed a calibrated ADCIRC model of the St. Johns River and its tributaries including Trout River (INTERA, 2018). This model was modified to increase resolution at the bridge site and along the Trout River. The mesh extends 100 miles to the north and south of the mouth of St. Johns River and 130 miles offshore into the Atlantic Ocean (Figure 3-1). St Johns River is included down to Lake George. The model mesh resolution changes from 4.5 miles at the offshore boundary to 50 ft at the bridge location (Figure 3-2 - Figure 3-4). This unstructured mesh provides high resolution along the important waterways, while keeping the total number of nodes and runtime manageable.

Figure 3-1 ADCIRC Mesh Full Extent

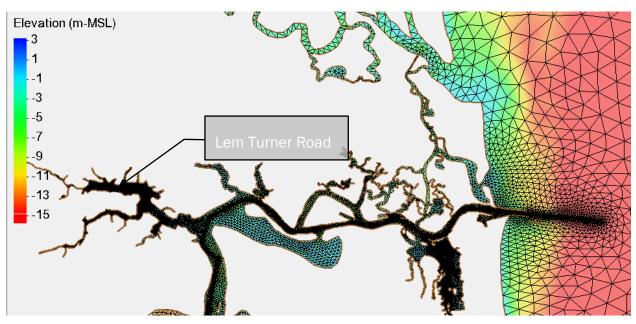
Figure 3-2 ADCIRC Mesh St. Johns River and Trout River

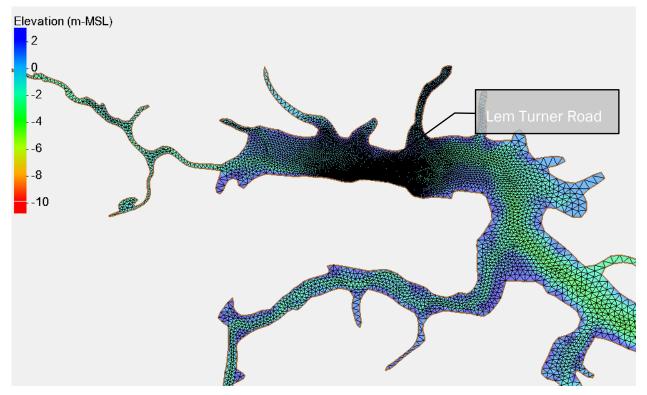
Figure 3-3 ADCIRC Mesh Trout River and Ribault River

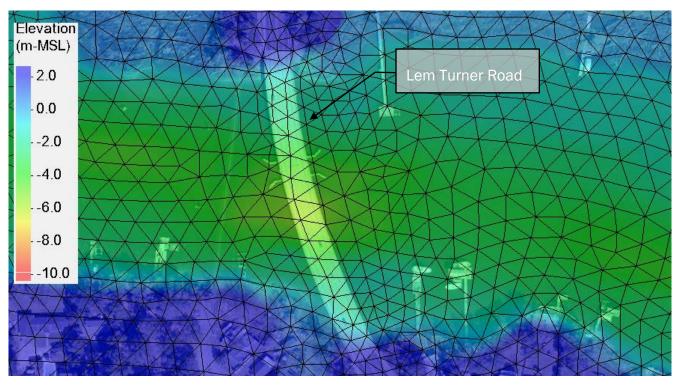
Figure 3-4 ADCIRC Mesh Lem Turner Bridge

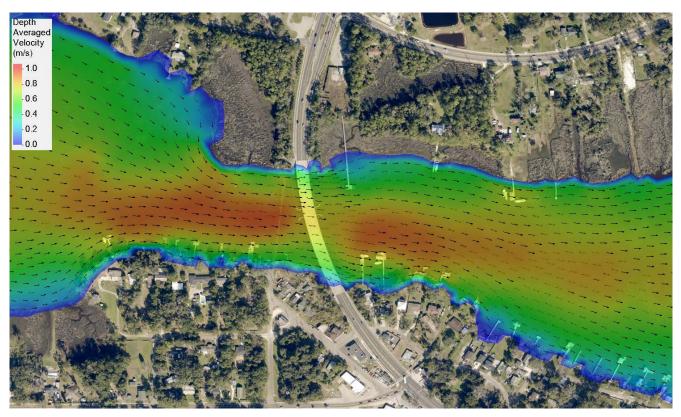
Results of the riverine simulations are summarized in Table 3-2. Riverine runoff with MLW downstream boundary condition causes no increase in stage but leads to high velocities. Figure 3-5 shows the 500-year flow velocities at the bridge location.

Figure 3-5 500-Year Runoff Velocity Magnitude Contour Plot

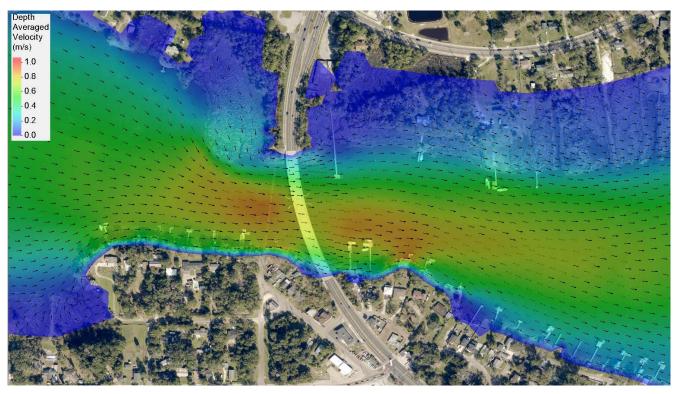
Results of the storm surge simulations are summarized in Table 3-3. Velocities decrease for larger return period events. This counterintuitive condition occurs frequently in storm surge simulations since water surface gradients are not a linear function of the maximum surge. Furthermore, discharges also decrease with increasing return period. Total amount of flux is larger for larger events, but due to the change in the shape of the hydrograph lower maximum flows may be observed. Figure 3-6 shows the 50-year flow velocities at the bridge location at the time of maximum velocities. Velocities peak before and after the maximum surge. The ebb flow creates the largest velocities.

Figure 3-6 50-Year Storm Surge Velocity Magnitude Contour Plot

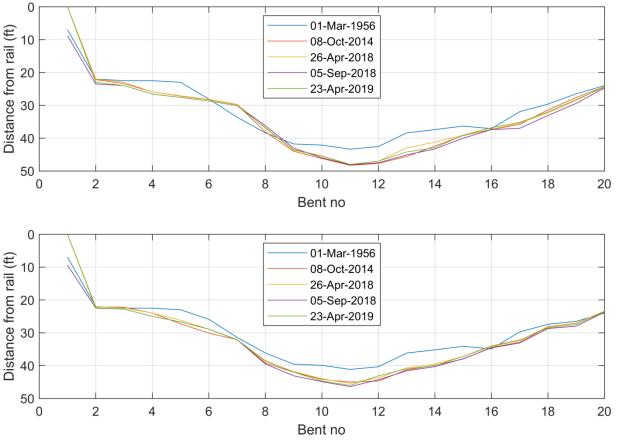
For this bridge, the FDOT provided channel cross-sections from Mar-1956, Oct-2014, 2Apr-2018, Sep-2018, and Apr-2019. Figure 4-1 presents the left and right profiles, and Figure 4-2 presents the left and right average change across bents 2-20 since 1956. Bent 1 was not included in the average change, because it was not measured some years. The waterway experienced 2.5 ft degradation from 1956 to 2014, but it is relatively stable from 2014 to 2019 with fluctuations around 0.5 ft. It is not clear if the waterway became stable after an initial adjustment after the bridge construction or still going through a slow degradation. There is no survey between 1956 to 2019 to confirm the long-term stability of the waterway, so a linear degradation pattern is assumed. The waterway degraded 2.5 ft in 63 years, so 3.0 ft degradation will be assumed for the 75-year planned lifetime of the bridge.

Figure 4-1 Left (Top) and Right (Bottom) Profiles (Source: FDOT Bridge Inspection Reports)

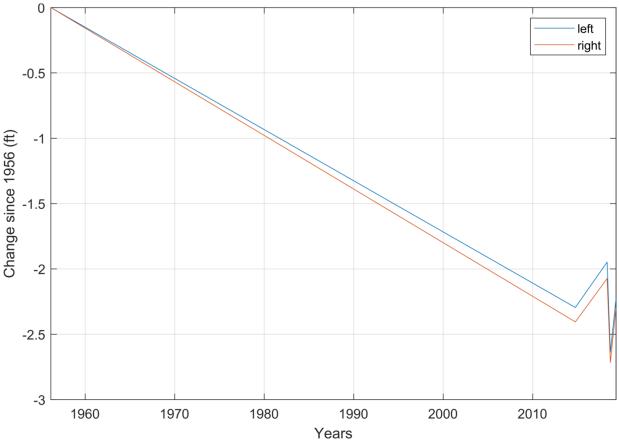
Figure 4-2 Average Change in Bed Elevation since 1956

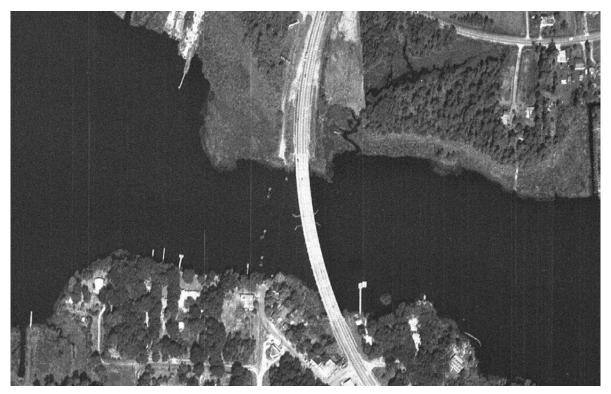
Figure 4-4 1969 FDOT Aerial Image

Figure 4-3 through Figure 4-12 present historic aerial images of the project location spanning from 1959 to 2021. During this period, the area surrounding the bridge was lightly developed, but the riverbank lines appear stable in the imagery record. Lateral migration is not a likely source of long-term scour for this bridge.

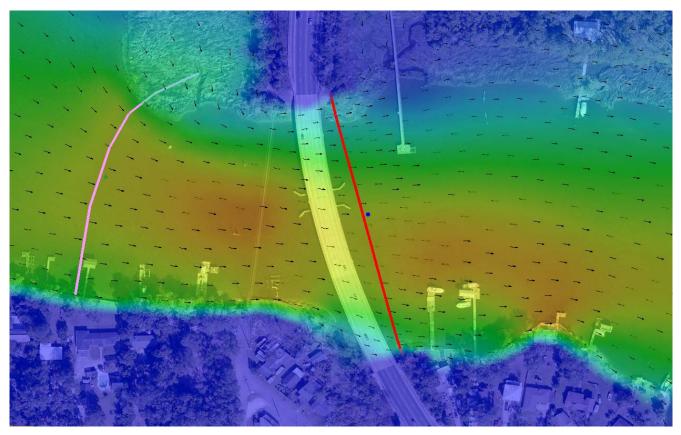
Figure 4-14 Contraction Scour Upstream and Bridge Cross Section Locations

Table 4.1 presents the contraction scour results for the base flood and greatest flood events. Surge conditions create larger flow rates and were used for contraction scour. As discussed in section 3.5 50-year surge created larger flow rates than 100-year surge and was used as the base flood. Based on their average flows, water depths, velocities, and replacement bridge geometry, both the base flood and the greatest flood produce zero contraction scour (Table 4.1). This is mainly due to the depths at the bridge cross-section already being larger than the approach cross-section.

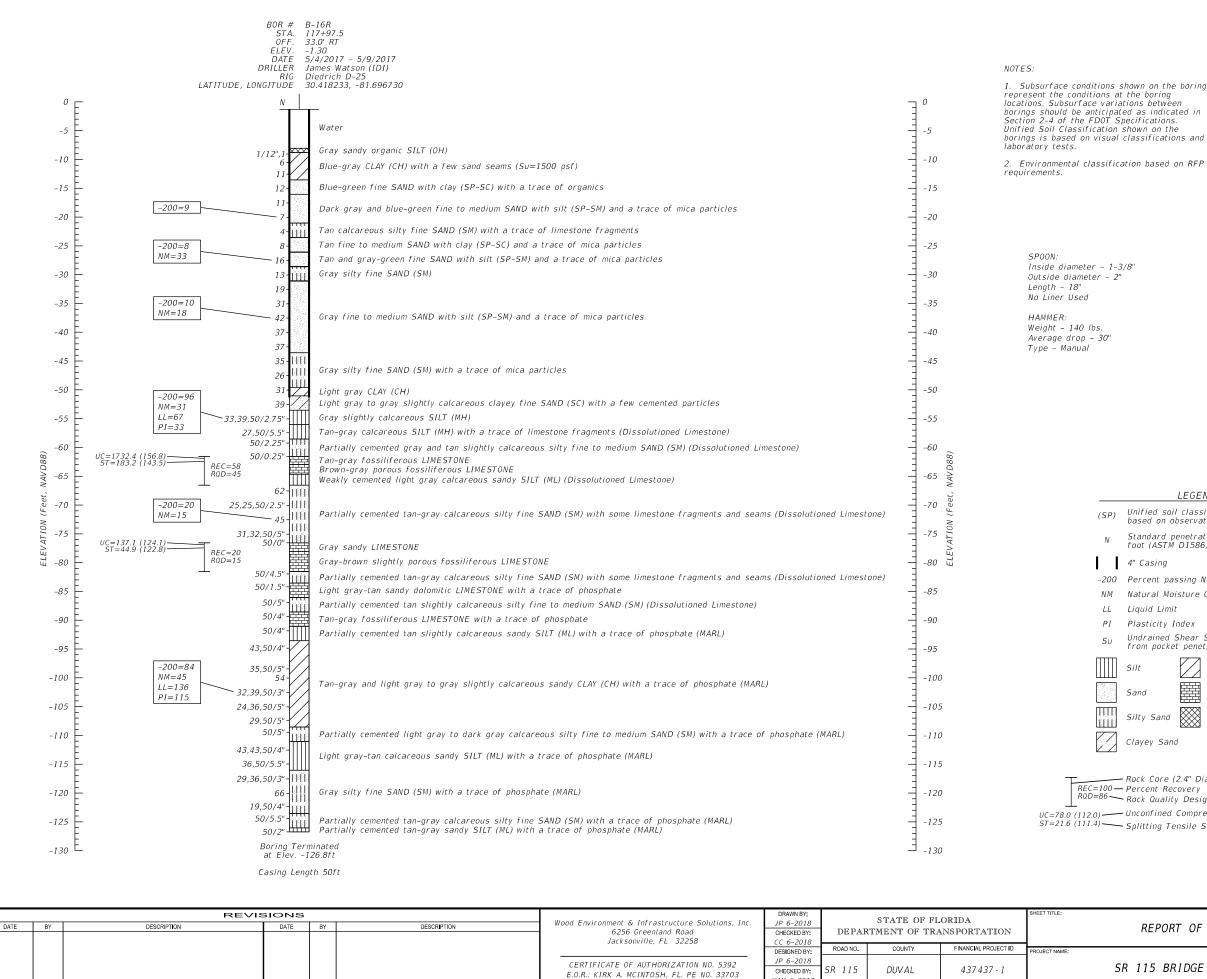
> BRIDGE NO. 720033 REF. DWG. NO REPORT OF CORE BORINGS SHEET NO. Page 2251 of 227 SR 115 BRIDGE OVER TROUT RIVER

- Rock Core (2.4" Dia.) RQD=86 — Rock Quality Designation UC=78.0 (112.0) — Unconfined Compressive Strength, ksf (Dry Unit Weight, pcf) ST=21.6 (111.4) — Splitting Tensile Strength, ksf (Dry Unit Weight, pcf)

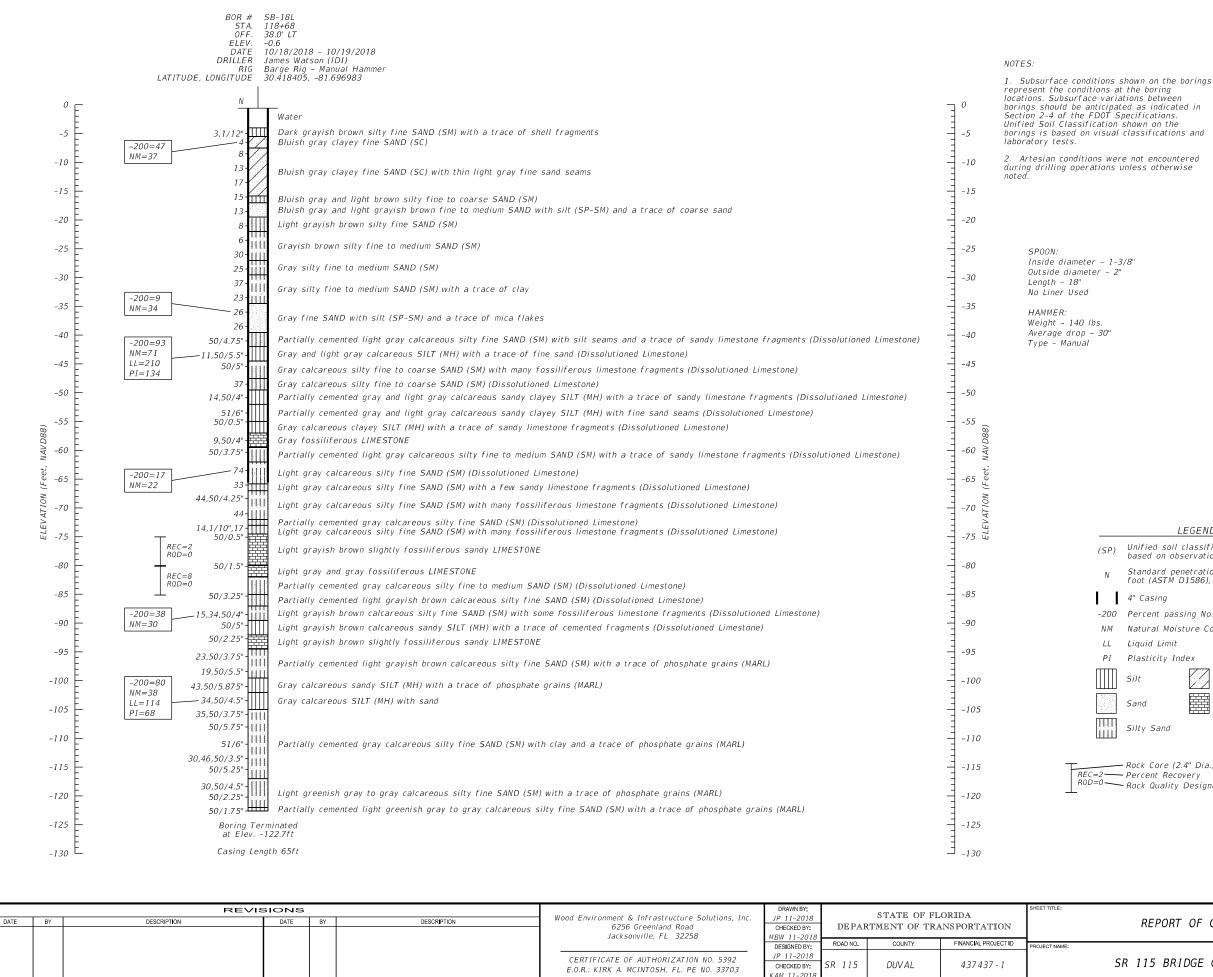
BRIDGE NO.	720033.
REPORT OF CORE BORINGS	REF. DWG. NO.
115 BRIDGE OVER TROUT RIVER Page 2255 of 227	7 SHEET NO.

- Rock Core (2.4" Dia.) RQD=0 — Rock Quality Designation

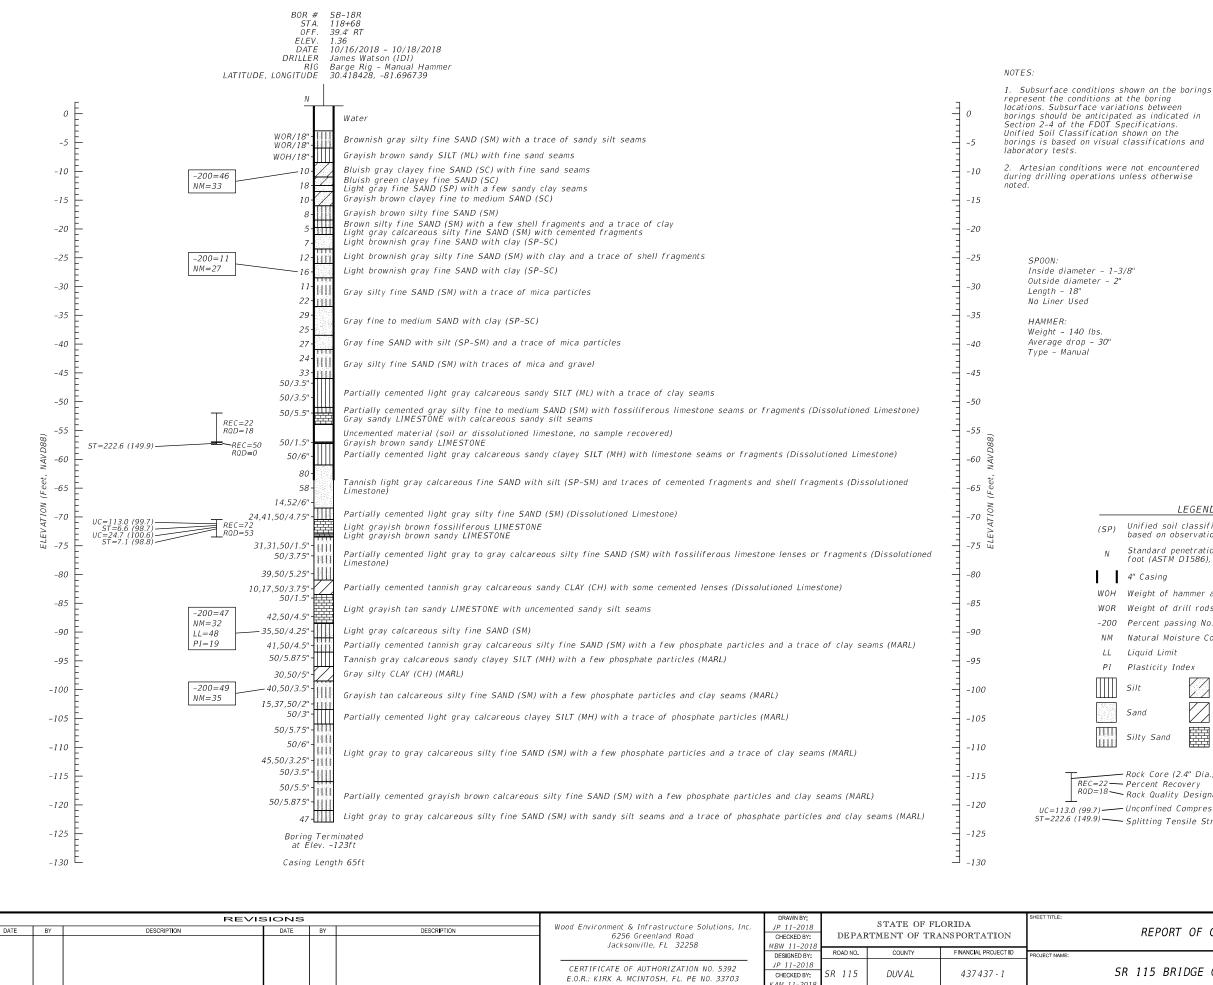
BRIDGE NO.	720033.
	REF. DWG. NO.
REPORT OF CORE BORINGS	
115 BRIDGE OVER TROUT RIVER Page 2256 of 227	7 <sup>SHEET NO.</sup>

- Rock Core (2.4" Dia.) RQD=18 — Rock Quality Designation UC=113.0 (99.7) — Unconfined Compressive Strength, ksf (Dry Unit Weight, pcf) ST=222.6 (149.9) —— Splitting Tensile Strength, ksf (Dry Unit Weight, pcf)

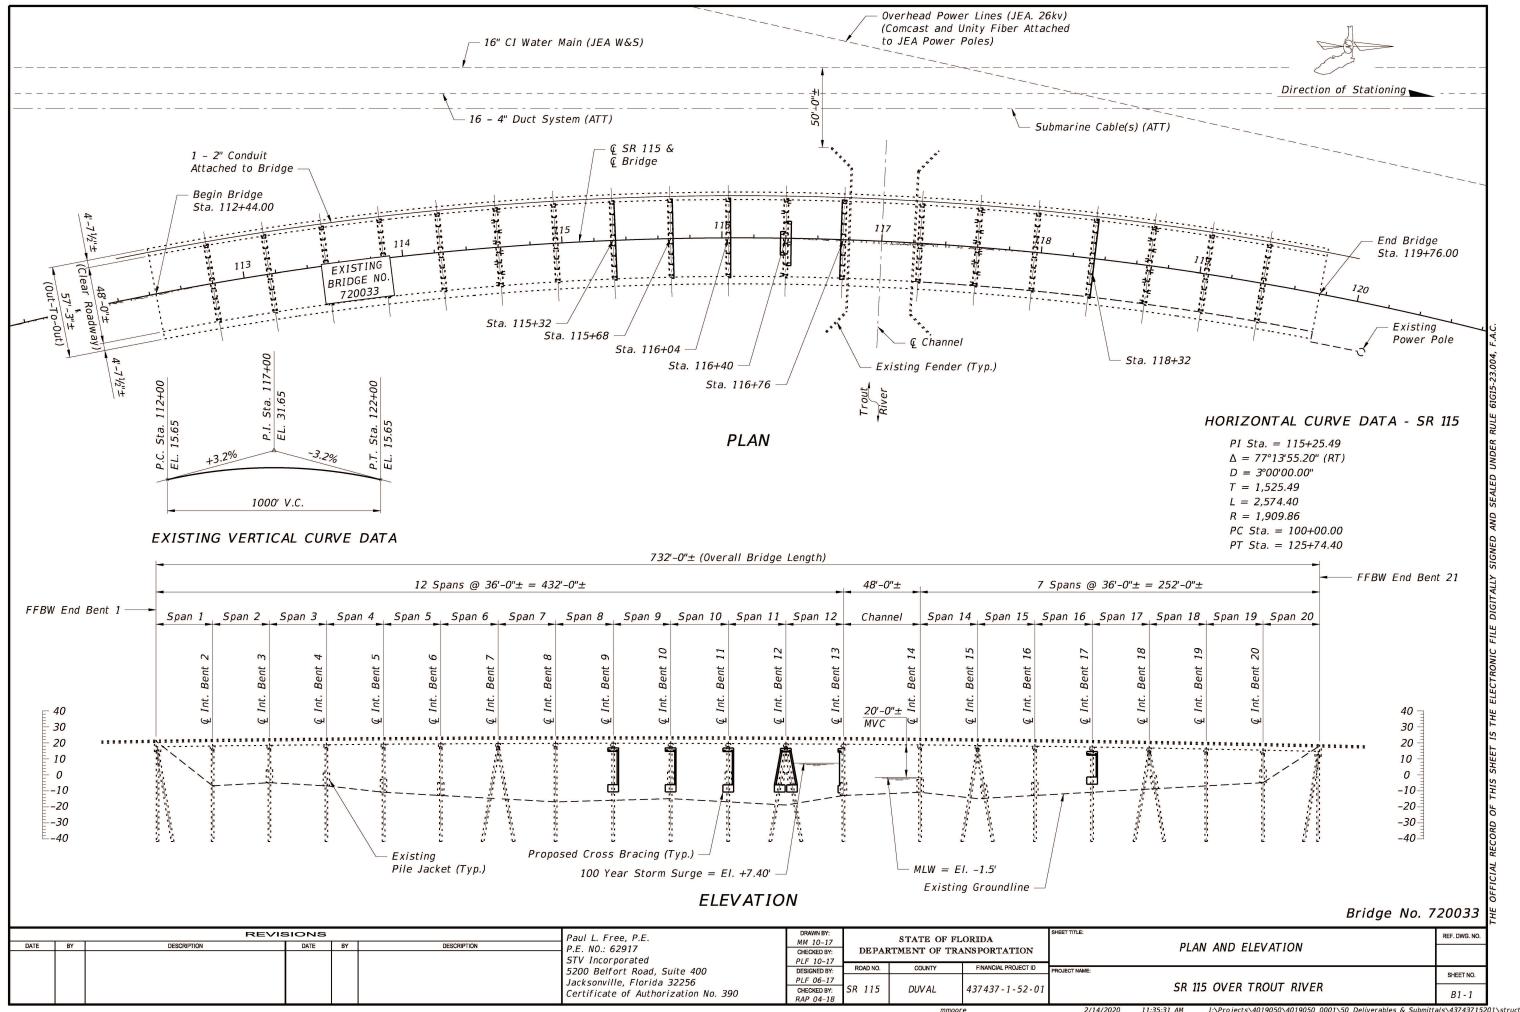
The existing bridge consists of nineteen 36' spans and one 48' navigational span with a total length of 732' (Appendix C). The eighteen interior inline bents have eight 20" square concrete piles. As a part of a repair project some of the piles have pile jacket increasing the width to 32" and some pile bents have brackets and cross-braces.

> Appendix C: Existing Bridge Plan and Profile
