**CULTURAL RESOURCE ASSESSMENT SURVEY  
FOR STATE ROAD 16 FROM INTERNATIONAL GOLF PARKWAY TO I-95  
ST. JOHNS COUNTY, FLORIDA**

**FINANCIAL MANAGEMENT No. 210447-5-32-01  
SEARCH PROJECT No. 230292**

**FLORIDA DEPARTMENT OF TRANSPORTATION, DISTRICT 2  
LAKE CITY, FLORIDA**

## EXECUTIVE SUMMARY

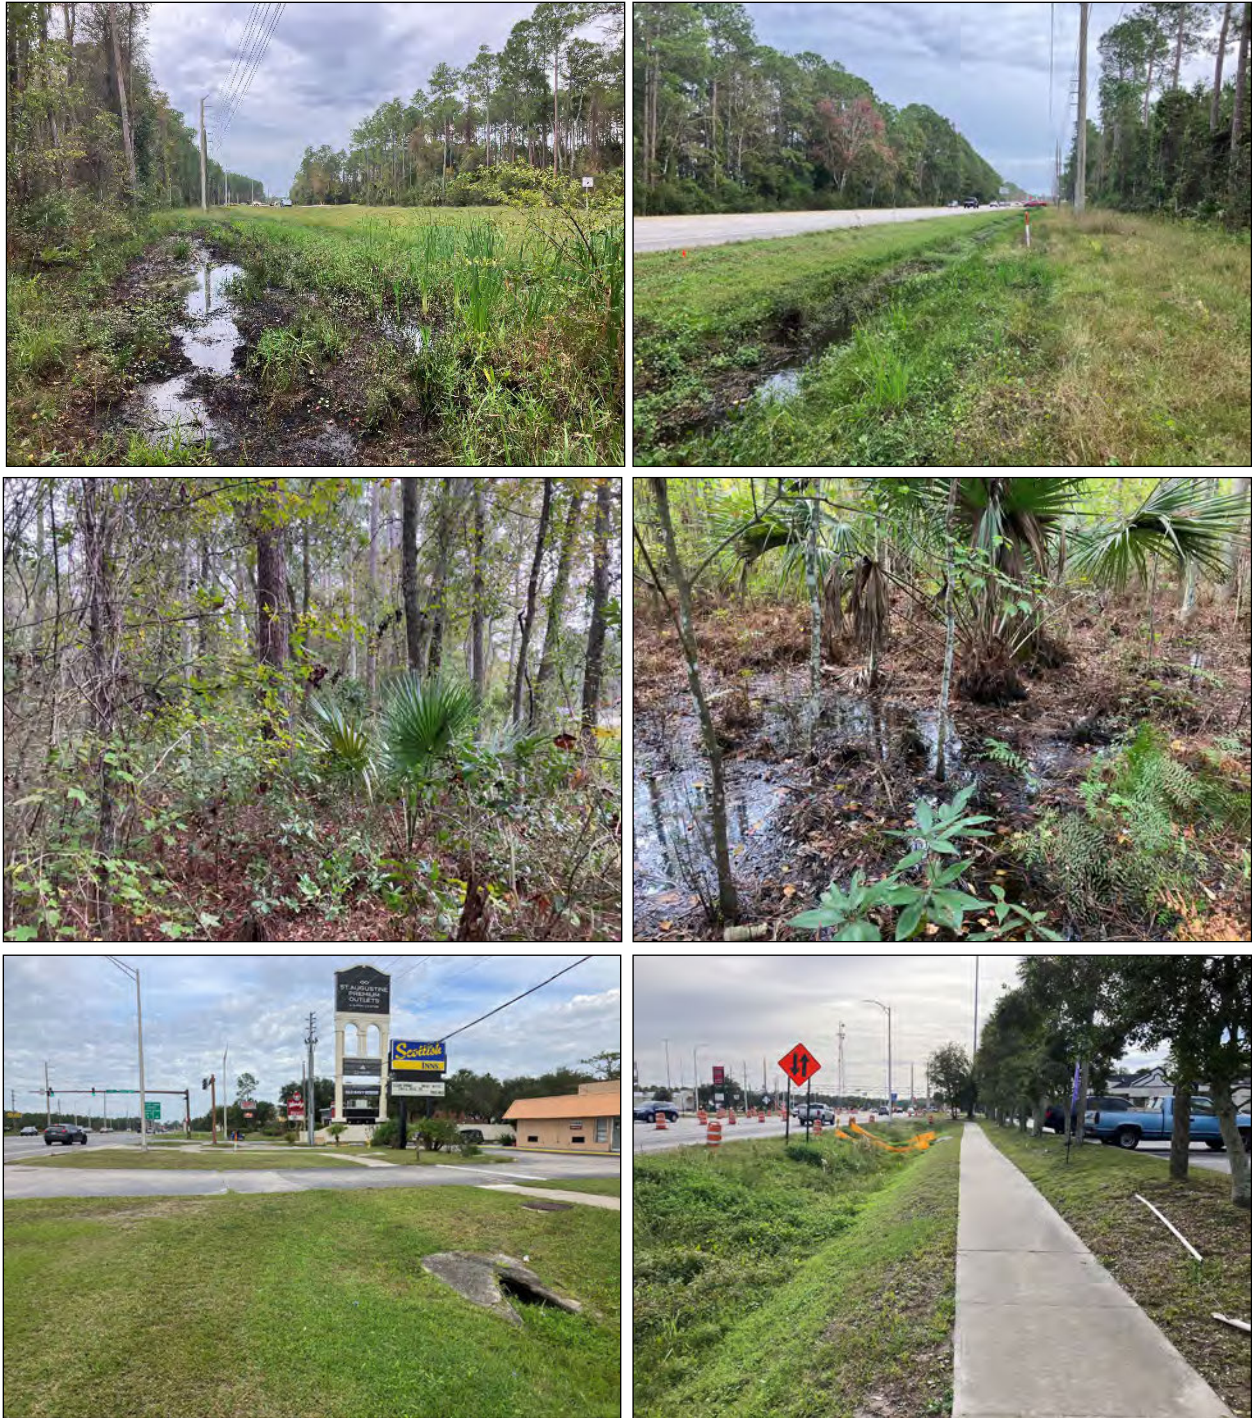
**Figure 11. Representative views of the corridor archaeological APE. Top left: inundated swale and buried utilities in northern portions of the APE, view northwest. Top right: inundated swale and buried utilities in northern portions of the APE, view southeast. Center left: environmental overview of APE north of Kohler Road, view south. Center right: inundated wetland within APE near 8SJ05310, view west. Bottom left: development, drainage, and buried utilities within the southern portions of the APE, view northwest. Bottom right: sidewalk, ditch, and buried utilities within the southern portion of the APE, view southeast.**

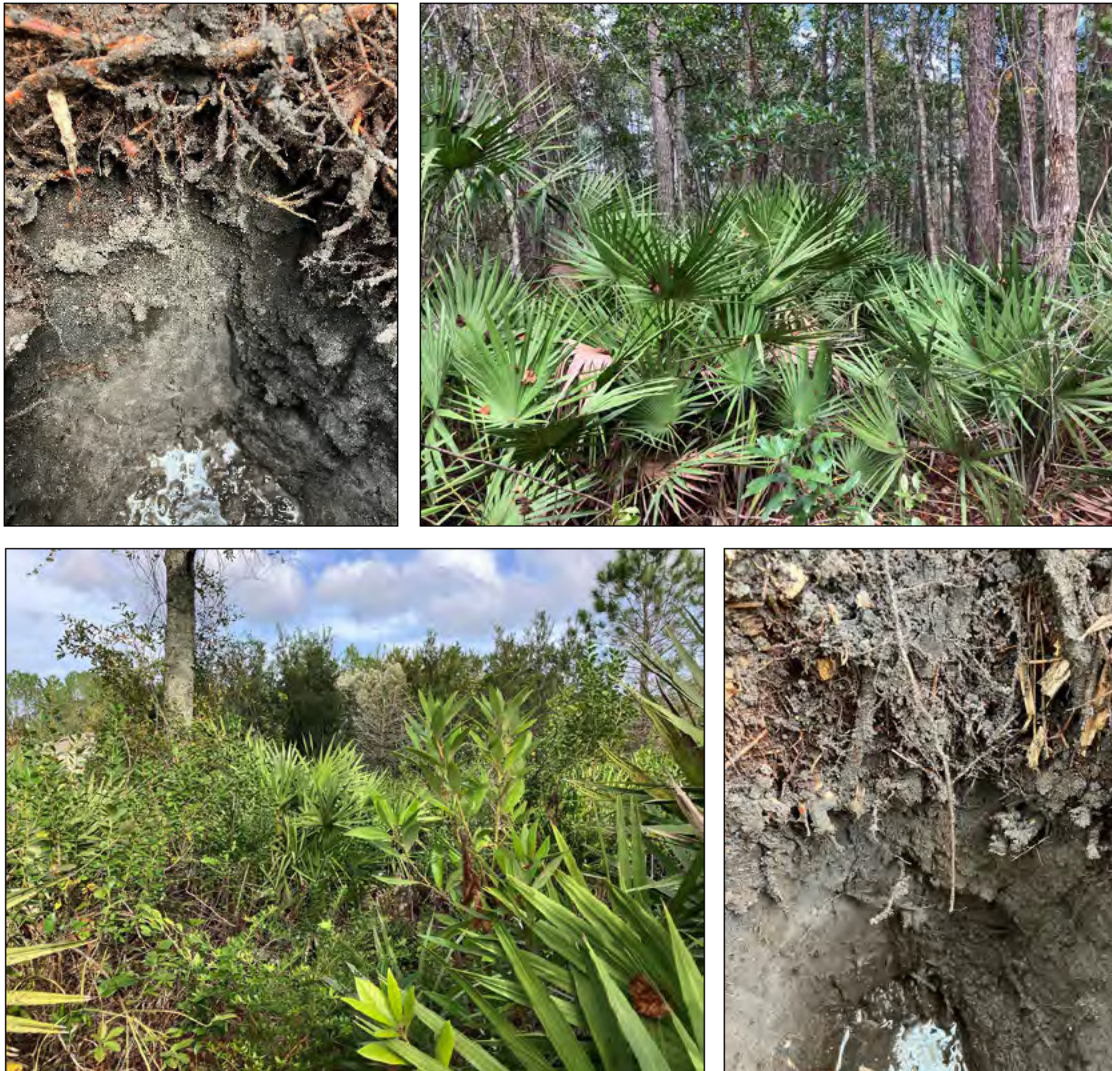
Figure 19. Representative views of the SR 16 APE. Top left: soil profile of shovel test N1420 E8457, north wall. Top right: environmental overview at shovel test N1420 E8457, view north. Bottom left: environmental overview at shovel test N2406 E7582, view east. Bottom right: soil profile of shovel test N2406 E7582, south wall.

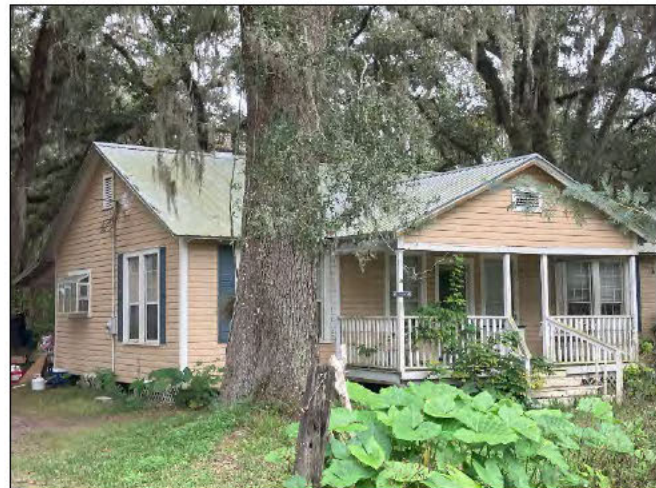
**Figure 25. Resource 8SJ04044 provides an example of the Frame Vernacular style within the APE. Photograph facing west.**

The Frame Vernacular style represents those ordinary wood-framed buildings designed on a basis of local need, material availability, and tradition (**Figure 25**). The local environment and experience of the builder, who was often not architecturally trained, provide more influence over the product than in most other styles (City of Miami 2017; Glassie 1990). Decoration is often sparse; however, examples of Frame Vernacular may be influenced by a variety of high styles.

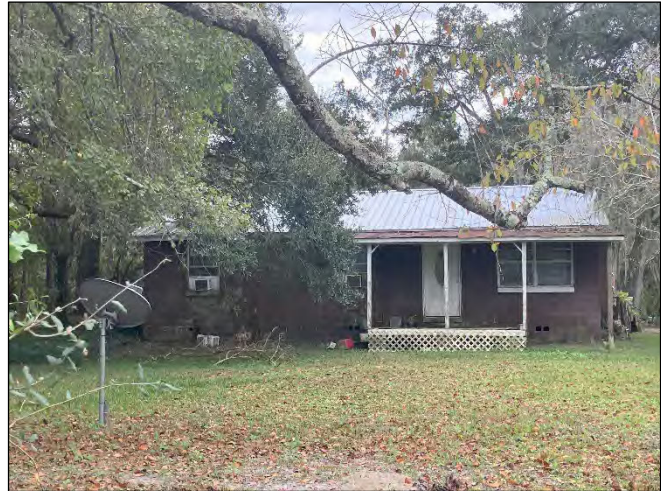
**Figure 26.** Resource 8SJ08218 provides an example of the Masonry Vernacular style within the APE. Photograph facing southwest.

Much like the Frame Vernacular style, Masonry Vernacular buildings were designed on a basis of local need, material availability, and tradition (**Figure 26**). Materials of this style include brick, cement block, oolitic limestone, Ocala block, hollow clay tile, stucco, and stone. Decoration is often sparse. However, examples of Masonry Vernacular may be influenced by a variety of high styles.

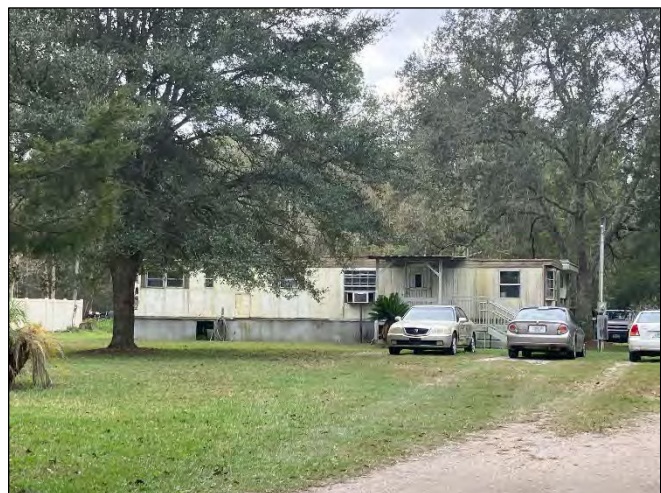
**Figure 27.** Resource 8SJ08217 provides an example of the Mobile Home style within the APE. Photograph facing south.

In the 1930s, travel trailers and campers emerged as some of the earliest examples of mobile homes (**Figure 27**). Their small size (they were generally no wider than 8 ft in the 1930s) meant that their use was most often restricted to that of a more mobile and transient nature (McAlester 2013:159). Symbols of motion, such as lightning or waves, were popular in early trailer design. Streamlined, vehicle-like bodies dominated the market. Doors usually featured a porthole or a rounded square window. The trailers were often metallic, rounded at front and back, the trailers were short in length, generally around 25 feet (Wallis 1991).

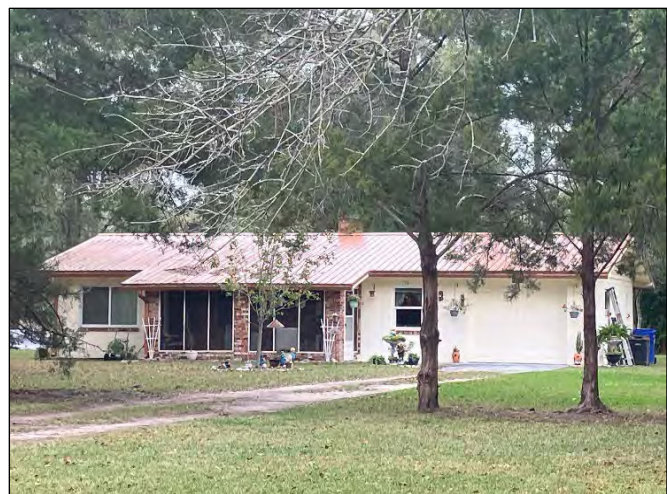
**Figure 28. Resource 8SJ08215 provides an example of the Ranch House style within the APE. Photograph facing north.**

The evolution of the Ranch style had multiple centers: the Chicago area, inspired by the Prairie Houses of Frank Lloyd Wright; the American southwest, the vestiges of working ranches providing inspiration; and California, where rapid growth in the early part of the twentieth century called for a new vernacular architecture undertaking (**Figure 28**) (Timberg 2005). California in the 1930s saw architects Cliff May, H. Roy Kelley, William Wurster, and others, adapting traditional houses of southwestern ranches, haciendas, and Spanish Colonial Revival styles to a suburban plan (NPS 2002:66). The initial popularity of the Ranch style can be attributed to its affordability and its references to the culture of the American West (Hubka 1995). Their ease of construction further contributed to their popularity during the post-World War II period, when families left the cities in droves (Salant 2006). The Ranch style was the most prevalent in the United States between 1940 and 1970 (Salant 2006). Exterior material of early ranches focused on natural material and often included adobe, board and batten, and brick (NPS

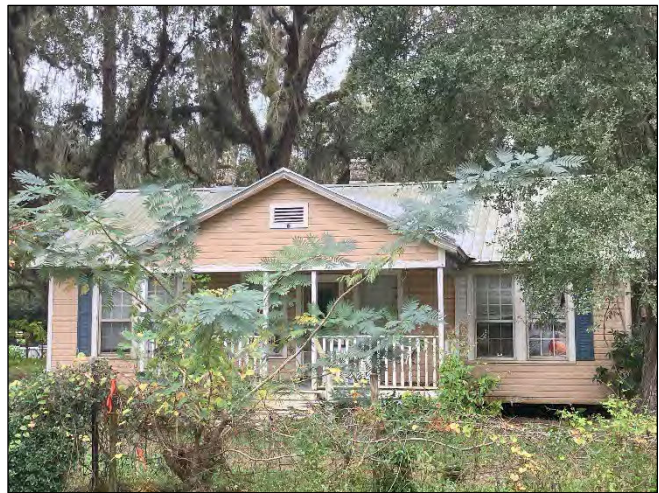
**Figure 29. Resource 8SJ04044 facing southwest.**

Resource 8SJ04044 (3955 SR 16) is a previously recorded ca. 1930 house in St. Johns County. The resource is in Section 41 of Township 6 South, Range 28 East, as depicted on the 2021 *Bakersville, Fla* USGS quadrangle map. The Frame Vernacular residence is on a rectangular parcel bounded to the northeast by SR 16 and to the east, west, and south by private parcels (**Figure 29**). Resource 8SJ04044 is a one-story, Frame Vernacular house on a rectangular plan raised above grade on a concrete block foundation. 5V crimp sheet metal covers the steeply pitched, cross-gabled roof, and wood clapboard clads the walls. The windows are paired, aluminum, sash windows with a nine-over-six configuration flanking the entry and creating a symmetrical elevation. The main entrance is on the south façade on a porch that projects from the main massing under the cross gabled roof.

Resource 8SJ04044 is not significant under Criterion A because it is not indicative of a particular era and is not associated with any significant period, event, or theme. The resource is not significant under Criterion B because it lacks association with any person(s) significant in history. Additionally, the resource is not significant under Criterion C due to its lack of architectural distinction. Finally, the resource is not significant under Criterion D because it lacks the potential to yield further information of historical importance. Therefore, SEARCH recommends 8SJ04044 ineligible for inclusion in the NRHP.

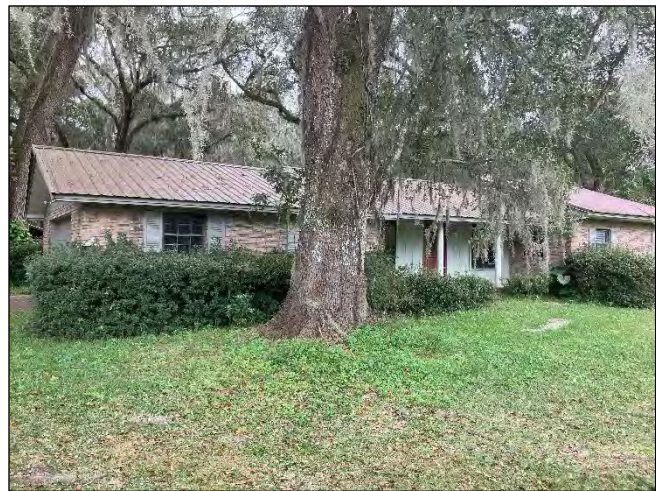
**Figure 30. Resource 8SJ05074 facing west.**

Resource 8SJ05074 (3975 SR 16) is a previously recorded house in St. Johns County. The resource is in Section 26 of Township 6 South, Range 28 East, as depicted on the 2021 *Bakersville, Fla* USGS quadrangle map and is on a rectangular parcel bounded to the northeast by SR 16 and to the east, west, and south by private parcels (**Figure 30**). Resource 8SJ05074 is a ca. 1947, one-story, Ranch-style residence with a rectangular plan set at grade on a concrete slab foundation. Metal 5V covers the shallow-pitched gable roof, and the exterior walls are brick with weatherboard accents. The windows consist of vinyl-framed sash windows with vinyl inserts to create a six-over-six configuration and are irregularly placed. The main entrance is on the southwest façade and consists of a wood-paneled door.

Resource 8SJ05074 is not significant under Criterion A because it is not indicative of a particular era and is not associated with any significant period, event, or theme. The resource is not significant under Criterion B because it lacks association with any person(s) significant in history. Additionally, the resource is not significant under Criterion C due to its lack of architectural distinction. Finally, the resource is not significant under Criterion D because it lacks the potential to yield further information of historical importance. Therefore, SEARCH recommends 8SJ05074 ineligible for inclusion in the NRHP.

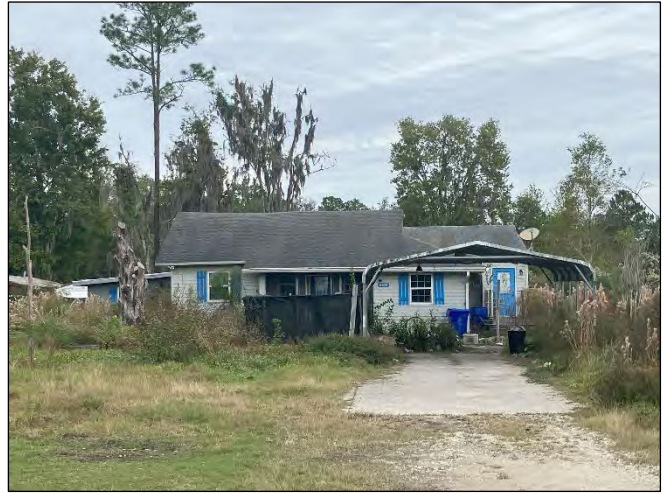
**Figure 31. Resource 8SJ05075 facing northeast.**

quadrangle map. The ca. 1941 building is on a rectangular parcel bounded to the southwest by SR 16 and to the east, west, and north by private parcels (**Figure 31**). Resource 8SJ05075 is a one-story, irregularly shaped Frame Vernacular-style residence with a continuous concrete foundation. The residence has a steep gable on hip and a flat roof covered in asphalt shingles and composition roll. The exterior is clad with aluminum and vinyl siding. The windows are vinyl sash windows; the front entrance is a metal door in a recessed screened porch on the northeast façade.

Resource 8SJ05075 is not significant under Criterion A because it is not indicative of a particular era and is not associated with any significant period, event, or theme. The resource is not significant under Criterion B because it lacks association with any person(s) significant in history. Additionally, the resource is not significant under Criterion C due to its lack of architectural distinction. Finally, the resource is not significant under Criterion D because it lacks the potential to yield further information of historical importance. Therefore, SEARCH recommends 8SJ05075 ineligible for inclusion in the NRHP.

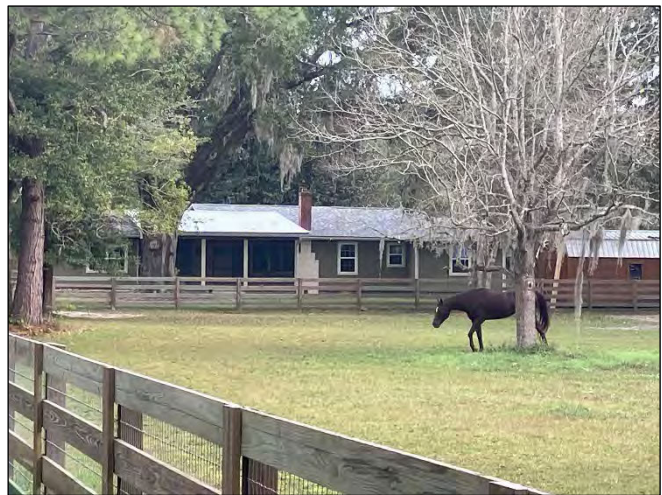
**Figure 32. Resource 8SJ05076 facing northeast.**

Resource 8SJ05076 (4700 SR 16) is a previously recorded house in St. Johns County. The resource is in Section 38 of Township 6 South, Range 28 East, as depicted on the 2021 *Bakersville, Fla* USGS quadrangle map. The ca. 1955 building is on a rectangular parcel bounded to the southwest by SR 16 and to the east, west, and north by private parcels (**Figure 32**). Resource 8SJ05076 is a one-story, Masonry Vernacular residence with a rectangular plan raised above grade on a concrete block foundation. Asphalt shingles cover the shallow-pitched gable roof, and the exterior walls are clad in concrete block. The front porch is in the center of the southwest façade and is completely screened in. Windows consist of aluminum-framed sash windows with six-over-six and one-over-one configurations. The main entrance is off the screened porch on the southwest façade.

Resource 8SJ05076 is not significant under Criterion A because it is not indicative of a particular era and is not associated with any significant period, event, or theme. The resource is not significant under Criterion B because it lacks association with any person(s) significant in history. Additionally, the resource is not significant under Criterion C due to its lack of architectural distinction. Finally, the resource is not significant under Criterion D because it lacks the potential to yield further information of historical importance. Therefore, SEARCH recommends 8SJ05076 ineligible for inclusion in the NRHP.

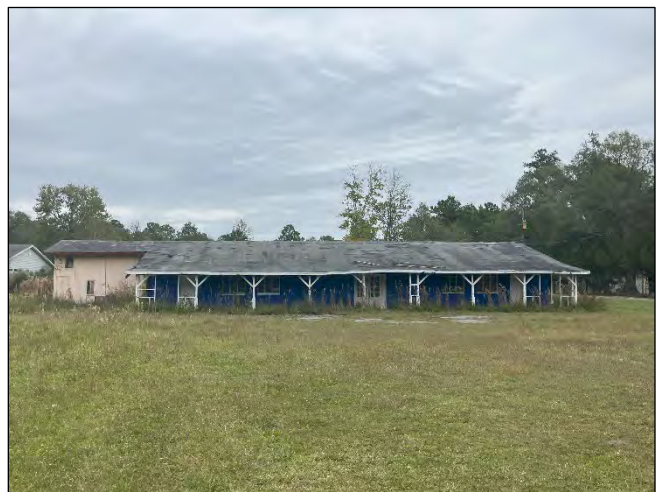
**Figure 33. Resource 8SJ08214 facing northeast.**

Resource 8SJ08214 (4606 SR 16) is a newly recorded commercial building in St. Johns County. The resource is in Section 38 of Township 6 South, Range 28 East, as depicted on the 2021 *Bakersville, Fla* USGS quadrangle map. The ca. 1970 building is on a rectangular parcel bounded to the southwest by SR 16 and to the east, west, and north by private parcels (**Figure 33**). Resource 8SJ08214 is a one-story, Frame Vernacular, commercial building with a rectangular plan on a poured-concrete slab foundation. The gable roof is covered in asphalt shingles, and the exterior walls are clad in painted concrete block. The residence has several aluminum casement windows, and the front entrance is in the center of the southwest façade. The porch that extends along the southwest elevation is supported by braced square posts.

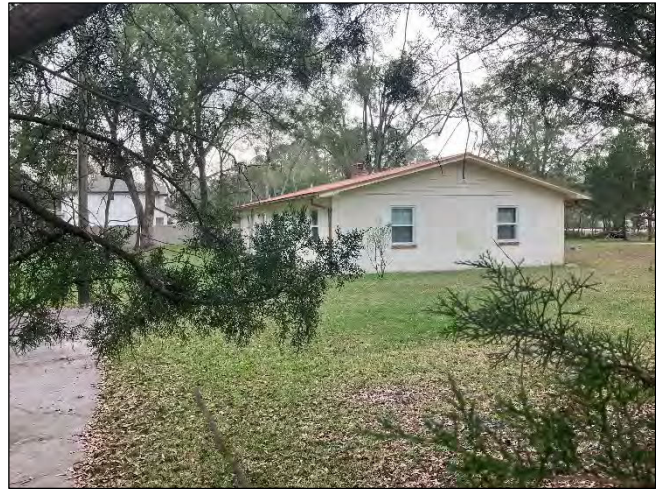
**Figure 34. Resource 8SJ08215 facing south.**

Resource 8SJ08215 (4590 SR 16) is a newly recorded house in St. Johns County. The resource is in Section 38 of Township 6 South, Range 28 East, as depicted on the 2021 *Bakersville, Fla* USGS quadrangle map. The ca. 1970 building is on a rectangular parcel bounded to the southwest by SR 16 and to the east, west, and north by private parcels (**Figure 34**). Resource 8SJ08215 is a one-story, Ranch-style residence with a rectangular plan set at grade on a concrete slab foundation. Metal 5V crimp covers the steeply pitched gable roof, and the exterior walls are concrete block. The front porch features brick and mesh windows. The windows consist of vinyl sash windows with a one-over-one configuration. The front entrance is obscured by vegetation.

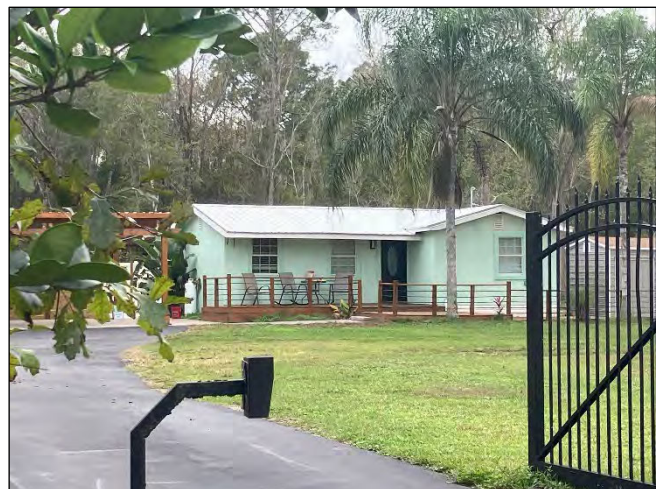
**Figure 35. Resource 8SJ08216 facing west.**

Resource 8SJ08216 (4571 SR 16) is a newly recorded house in St. Johns County. The resource is in Section 38 of Township 6 South, Range 28 East, as depicted on the 2021 *Bakersville, Fla* USGS quadrangle map. The ca. 1970 building is on a rectangular parcel bounded to the northeast by SR 16 and to the east, west, and south by private parcels (**Figure 35**). Resource 8SJ08216 is a one-story, Masonry Vernacular residence with an L-shaped plan set at grade on a concrete slab foundation. Metal 5v crimp covers the shallow-pitched, gross-gabled roof, and stucco clads the exterior walls. The front façade features a raised deck with wood railing on the east elevation. Windows are vinyl-

framed sash windows with a six-over-six configuration. The front entrance is off the raised porch on the east façade.

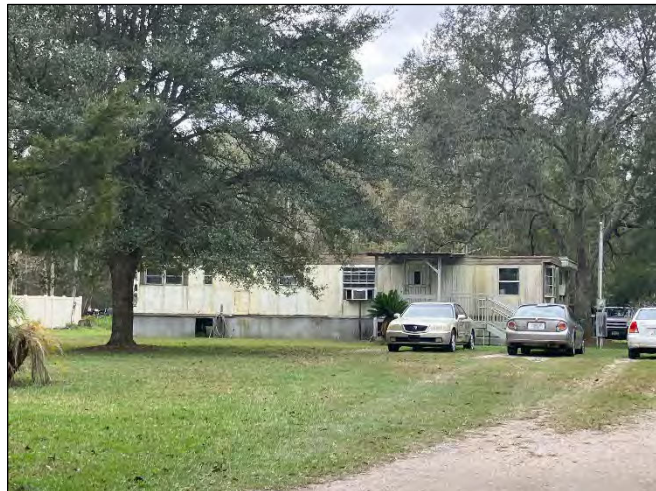
**Figure 36. Resource 8SJ08217 facing south.**

Resource 8SJ08217 (4585 SR 16) is a newly recorded mobile home in St. Johns County. The resource is in Section 38 of Township 6 South, Range 28 East, as depicted on the 2021 *Bakersville, Fla* USGS quadrangle map. The ca. 1973 building is on a rectangular parcel bounded to the northeast by SR 16 and to the east, west, and south by private parcels (**Figure 36**). Resource 8SJ08217 is a one-story Mobile Home with a rectangular plan set on obscured piers. The flat roof is covered in composition roll, and the walls are clad in metal. Windows are aluminum-framed windows with a one-over-one and a six-over-six configuration. The main entrance is on the south façade.

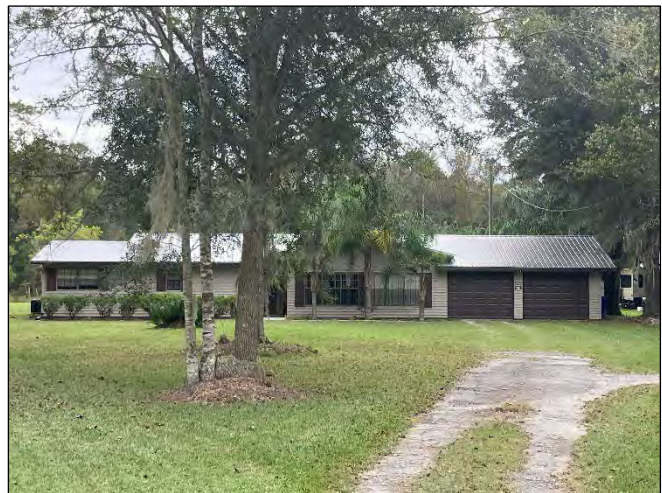
**Figure 38. Resource 8SJ08219 facing south.**

Resource 8SJ08219 (4065 SR 16) is a newly recorded house within St. Johns County. The resource is in Section 26 of Township 6 South, Range 28 East, as depicted on the 2021 *Bakersville, Fla* USGS quadrangle map. The ca. 1969 building is on an irregularly shaped parcel bounded to the northeast by SR 16 and to the east, west, and south by private parcels (**Figure 38**). Resource 8SJ08219 is a one-story, Ranch-style residence with an irregular plan set at grade on a concrete slab foundation. Metal 5V crimp covers the shallow-pitched cross-gabled roof, and vinyl drop siding clads the exterior walls. Windows consist of paired, aluminum-framed sash windows with six-over-six and

one-over-one configurations. Windows are decorated with faux shutters. The main entrance is a recessed panel door on the south façade.

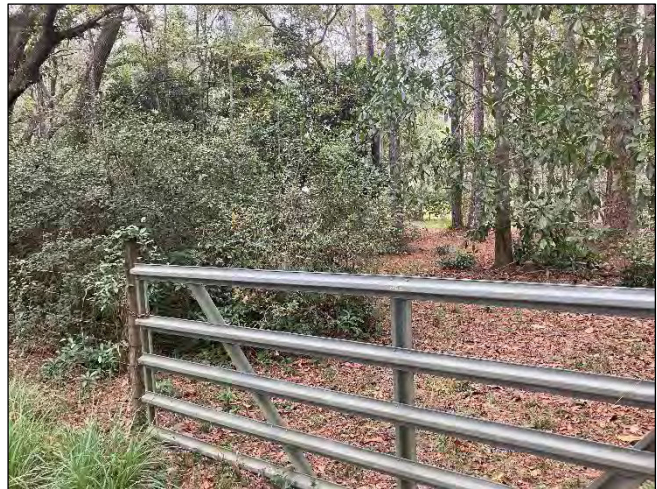
**Figure 39. Resource 8SJ08220 facing northwest.**

Resource 8SJ08220 (3940 SR 16) is a newly recorded house within St. Johns County. The resource is not visible from the ROW or from adjacent parcels; thus, information is based on its St. Johns County Property Appraiser (SJCPA) record. The resource is in Section 41 of Township 6 South, Range 28 East, as shown on the 2021 *Bakersville, Fla.* USGS quadrangle map. The ca. 1973 building is on the southern portion of an irregularly shaped parcel bounded by SR 16 along the southern perimeter (**Figure 39**). The Frame Vernacular residence is obscured from the ROW by dense vegetation. The building is not visible from the ROW or from adjacent parcels. Its material qualities were not observed during the survey.

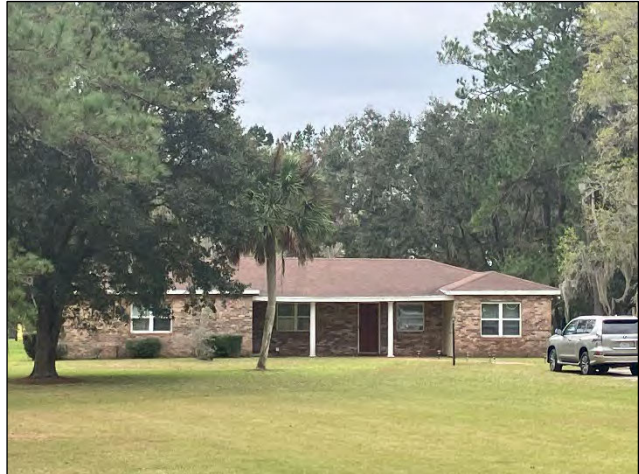
**Figure 40. Resource 8SJ08221 facing southwest.**

Resource 8SJ08221 (3795 SR 16) is a newly recorded house in St. Johns County. The resource is in Section 38 of Township 6 South, Range 28 East, as depicted on the 2021 *Bakersville, Fla* USGS quadrangle map. The ca. 1975 building is on a rectangular parcel bounded to the northeast by SR 16 and to the east, west, and south by private parcels (**Figure 40**). Resource 8SJ08221 is a one-story, Ranch-style residence with an L-shaped plan set at grade on a concrete slab foundation. Asphalt shingles cover the shallow-pitched hip roof, and the exterior walls are concrete block with a brick façade on the southwest elevation. The windows consist of fixed, vinyl-framed picture windows and vinyl-framed sash windows with a one-over-one configuration. The main entrance is on the southwest façade; it is a wood panel door with a roof overhang and two beams, which creates a sheltered entrance.

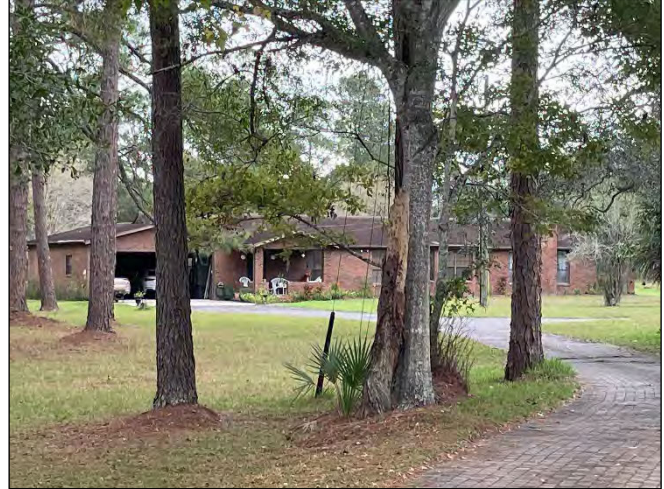
**Figure 41. Resource 8SJ08222 facing east.**

Resource 8SJ08222 (3726 SR 16) is a newly recorded house in St. Johns County. The resource is in Section 38 of Township 6 South, Range 28 East, as depicted on the 2021 *Bakersville, Fla* USGS quadrangle map. The ca. 1960 building is on an irregularly shaped parcel bounded to the southwest by SR 16 and to the east, west, and north by private parcels (**Figure 41**). Resource 8SJ08222 is a one-story, Ranch-style residence with an irregular plan set at grade on a concrete slab foundation. Asphalt shingles cover the shallow-pitched, cross-gabled roof, and the exterior walls are clad in brick. The windows consist of aluminum-framed sash windows with one-over-one and six-over-six configurations and an aluminum-framed bay window. The main entrance is obscured from view by vegetation.

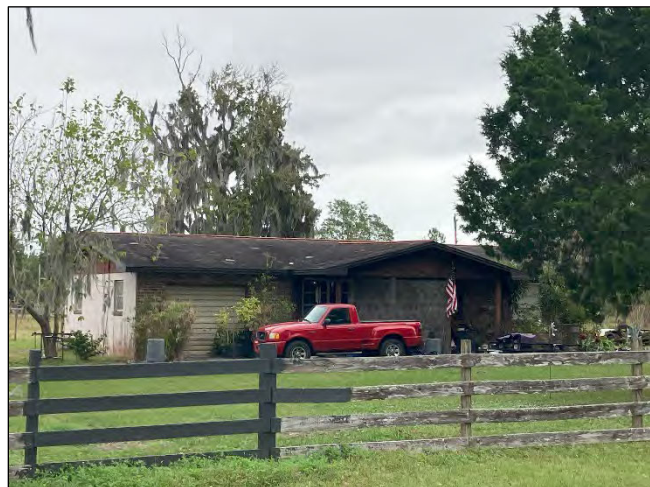
**Figure 42. Resource 8SJ08223 facing east.**

Resource 8SJ08223 (3050 SR 16) is a newly recorded house in St. Johns County. The resource is in Section 31 of Township 6 South, Range 29 East, as depicted on the 2021 *Bakersville, Fla* USGS quadrangle map. The ca. 1973 building is on an irregularly shaped parcel bounded to the southwest by SR 16 and to the east, west, and north by private parcels (**Figure 42**). Resource 8SJ08223 is a one-story, Ranch-style residence with a rectangular plan on a poured-concrete slab foundation. The cross-gabled roof is covered in asphalt shingles, and the exterior is clad in brick.

and concrete block. The windows consist of vinyl-framed sash windows with one-over-one configurations and aluminum-framed awning windows. The main entrance is on the west façade and is obscured by a partially screened porch. A gable protrusion in the middle of the west-facing elevation creates a covered porch at the entry. It is supported by wooden posts.

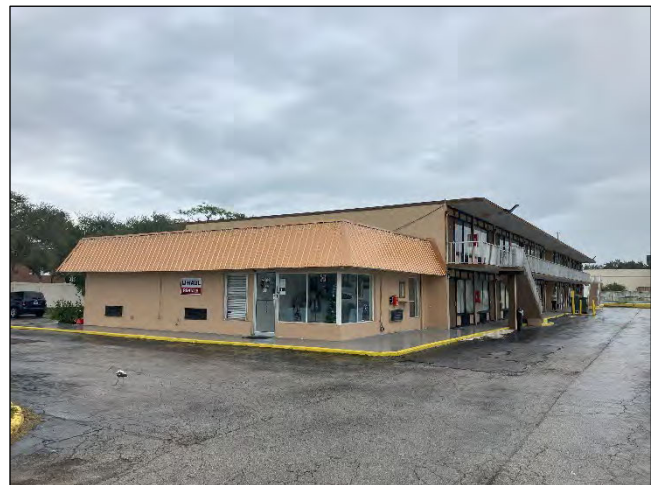
**Figure 43. Resource 8SJ08224 facing northeast.**

Resource 8SJ08224 (2580 SR 16) is a newly recorded hotel in St. Johns County. The resource is in Section 6 of Township 7 South, Range 29 East, as depicted on the 2021 *Bakersville, Fla* USGS quadrangle map. The ca. 1975 building is on a rectangular parcel bounded to the southwest by SR 16 and to the east, west, and north by private parcels (**Figure 43**). Resource 8SJ08224 is a two-story, Masonry Vernacular hotel with a rectangular plan on a poured-concrete slab foundation. The mansard roof is covered in sheet metal, and the flat roof is built up. The exterior walls are clad in concrete block and stucco. The main block of rooms is a two-story building, and the office is in an attached one-story building on the south end of the two-story building. The rooms are accessed from exterior metal doors and have fixed picture windows. A staircase at each end of the building provides access to the rooms on the second floor.

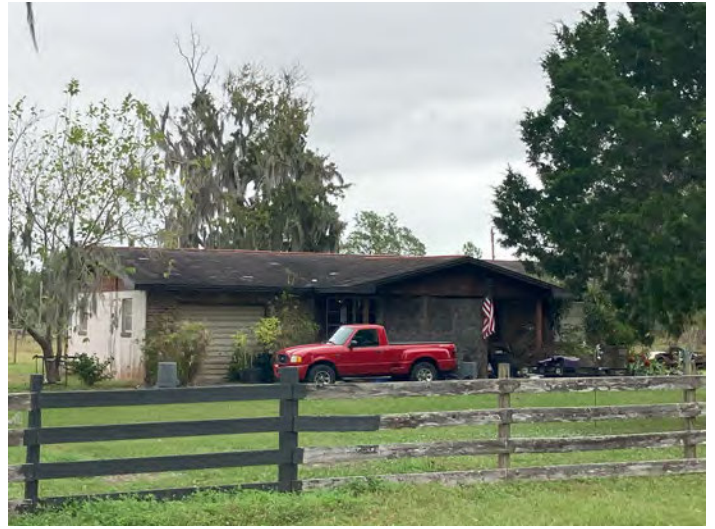
8SJ08223\_b Facing East

Resource 8SJ08223 is a one-story Ranch house with a rectangular plan on a poured concrete slab foundation. The cross-gable roof is covered in asphalt shingles, and the exterior is clad in brick and concrete block.

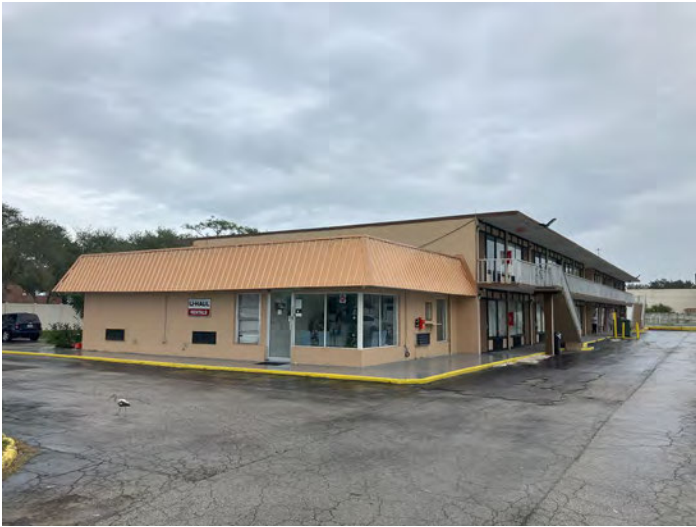
8SJ08224\_a Facing Northeast

Resource 8SJ08224 is a two-story Masonry Vernacular hotel with a rectangular plan on a poured concrete slab foundation. The mansard roof is covered in sheet metal, and the flat roof is built up. The exterior walls are clad in concrete block and stucco.

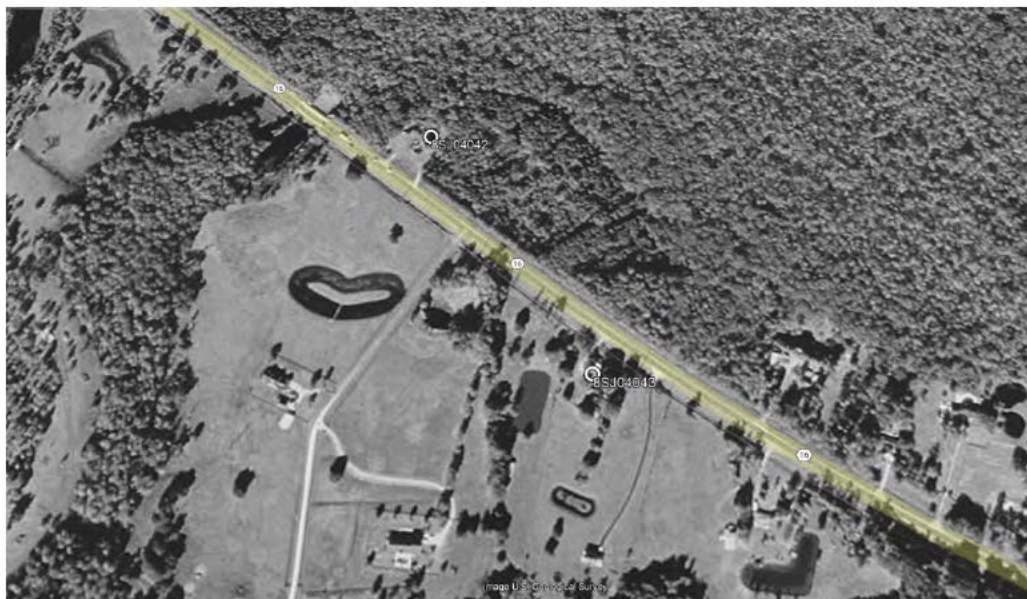
<i>Historic Buildings</i>				
FMSF No.	Name/Address	Demolished or Misplotted	Year Built	SHPO Evaluation
8SJ04042	4250 SR 16	Demolished; Figure 1	1935	Ineligible (April 11, 2007)
8SJ04043	4125 SR16	Demolished; Figure 1	1910	Ineligible (April 11, 2007)

**Figure 1. Mapped location of 8SJ04042 and 8SJ04043 in 2023 (top) and 1999 (bottom) (Google Earth 2023, 1999)**
