Subject: FM No. 210447-5-32-01 PD&E SR 16 Widening, St Johns Co, FL

Supplemental Pond Contamination Screening Evaluation and Assessment:

Pond Site 5C Screening Evaluation & Pond Sites 4B and 4C Assessment Summary

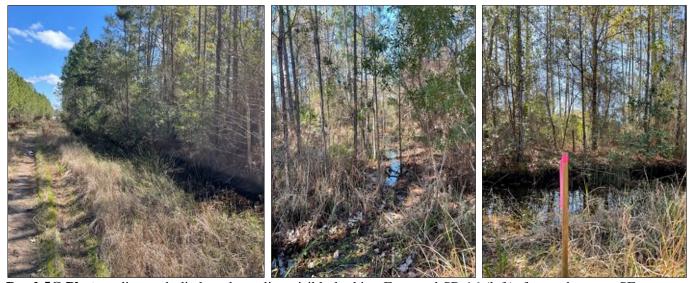
A site reconnaissance of Pond 5C occurred on February 20, 2025. The pond site was vegetated with Flatwoods tree and shrub cover, intermixed forested uplands and wetlands. An unpaved road and constructed drainage ditch were also present within the length of the proposed pond site. The ditch was approximately 8-10 ft wide and wet throughout the pond area. Small piles of mounded soil were noted adjacent to a wider section of the ditch. No trash or debris was visible in the mounds. The mounds were likely created when this portion of the ditch was over excavated. See Pond 5C photos below.

**Pond 5C Photos:** dirt road, ditch and tree line visible looking E toward SR 16 (left), forested area at SE corner looking east (middle), from dirt road looking S at wide section of ditch and soil mounds (right).

No potential contaminated sites were identified within the vicinity of Proposed Pond Site 5C, it is ranked as a NO risk. Impacts to construction are not anticipated at this time.

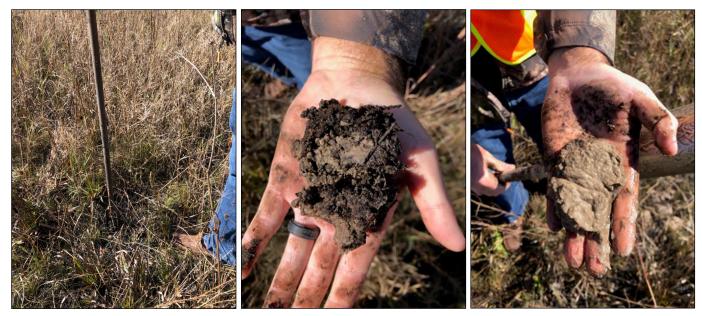
A field site evaluation and soil assessment of the depressional area within proposed Pond Sites 4B and 4C was conducted on November 21, 2024. Observations of the ground's surface, vegetation, and surface soils were made. The surface soils in the depressional area were wet. The vegetation types indicated a high groundwater water table was a dominate hydrologic feature. Soil borings, advanced with a hand auger to approximately three feet below land surface (bls), encountered the groundwater table between 8 to 12 inches bls. The observed soils were dark, organic sandy soils over light yellowish-brown sand. See **Pond 4B and 4C photos** below. The soil boring locations are shown on **Figure 2.**

No foreign material or indications of disturbed or contaminated soils were noted in the subsurface soils. The soil profiles observed were consistent with naturally occurring soil formation and were comparable to the local soils mapped in the Natural Resource Conservation Service (NRCS) St John County Soil Survey. The hydrologic changes observed at Ponds 4B and 4C in the historical aerials were likely related to changes in the drainage and stromewater control features along SR 16 and surrounding area. The depressional area did not appear to be filled with material from outside sources.

**Pond 4B and 4C photos**: Soil boring location #2 (left), organics in the near surface soil (middle), sandy subsurface soils (right).

Based on the additional investigation, the Level 1 CSER (2024) risk rankings for Pond Sites 4B and 4C have been reduced from MEDIUM to LOW risk. No further assessment is recommended.

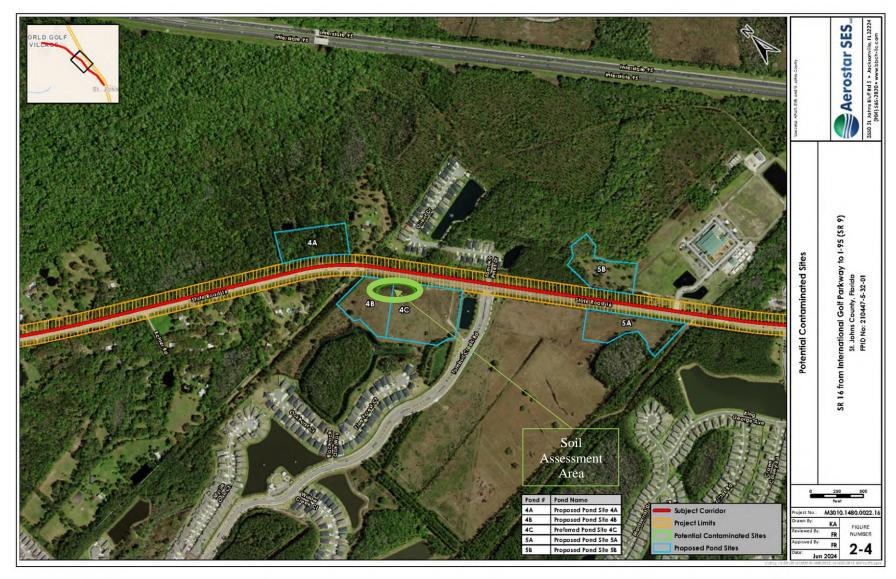
Figure 1- Location of low-lying area in SR 16 Proposed Ponds 4B and 4C

Further evaluation of proposed Pond Sites 4B and 4C was necessary based on concerns described in the SR 16 Level 1 CSER (2024), which ranked both ponds as MEDIUM risk sites. The MEDIUM risk rankings were assigned based on observations in the historical aerials review showing notable landscape changes between 1980 and 1993 in a low-depressional area present within both 4B and 4C pond sites. The observed changes potentially indicated the depressional area was filled in with material of an unknown origin, i.e. trash, debris, contaminated soils. The pond sites and depressional area are shown on **Figure 1**.

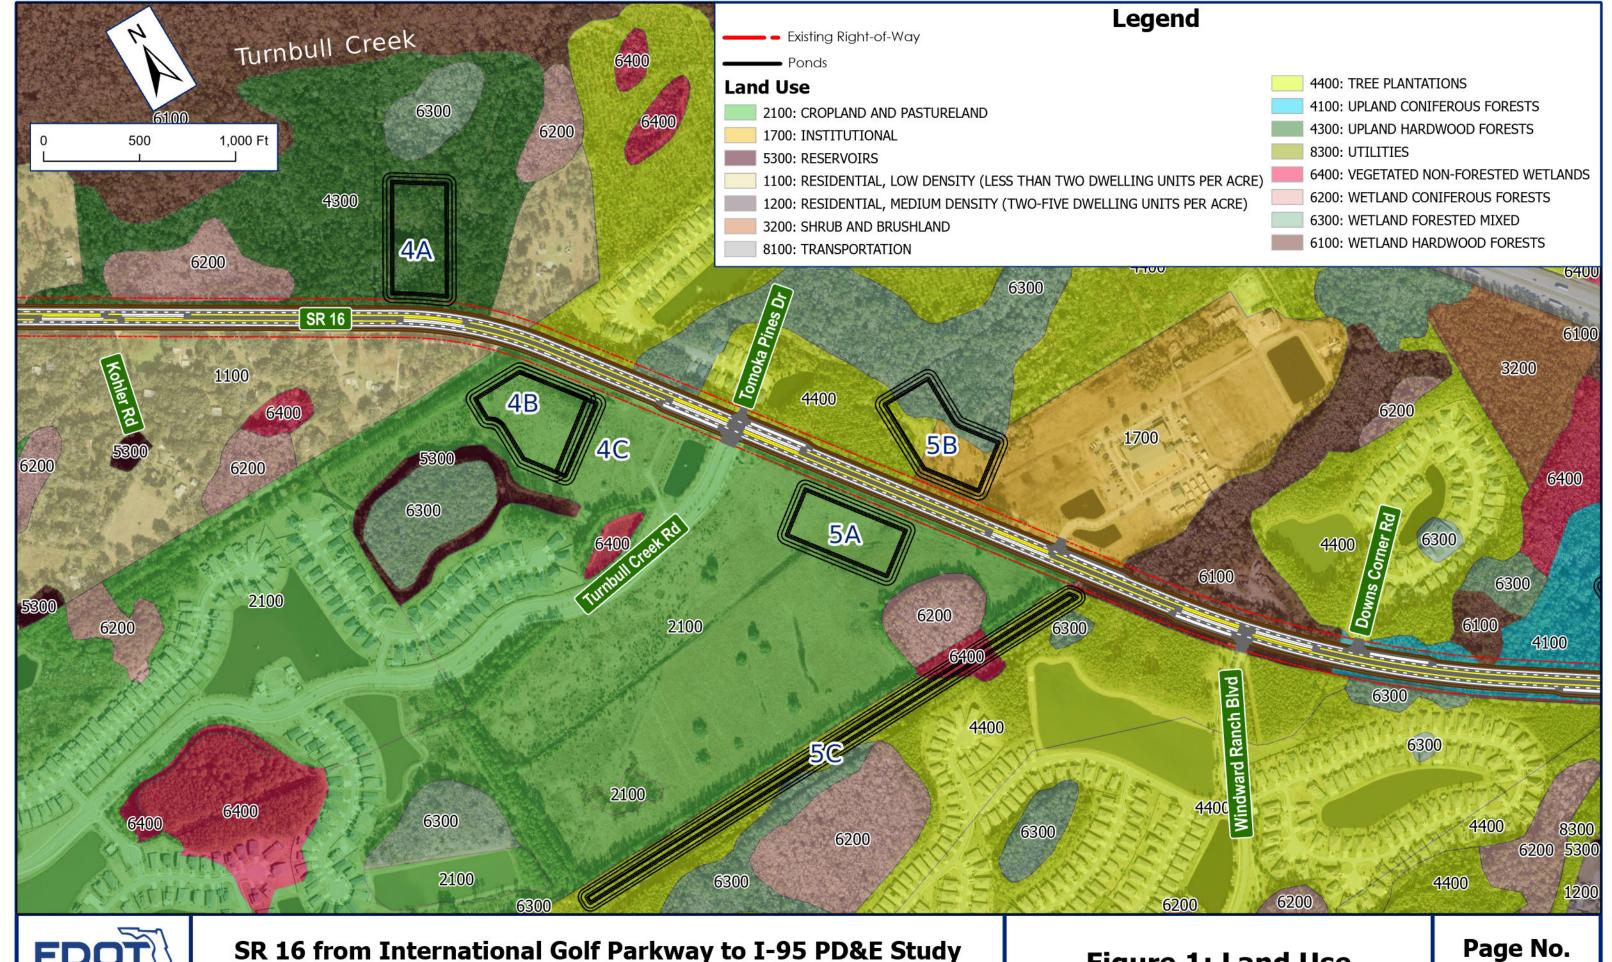
Figure 1: Land Use

Pond 5C is a long, linear pond, covering approximately 8.14 acres. The location of Pond 5C is shown in the project's draft Pond Siting Report Figure 1. Land Use (Jan 2025), see **Attachment 1**. The pond site is perpendicular to SR 16 and adjacent to the southern portion of Pond 5A. Pond 5A ranked was ranked as a No risk in the SR 16 CSER (2024).

Pond 5C location as shown in the SR 16 draft Pond Siting Report
Figure 1. Land Use
Date of draft report is January 2025
